**Joint Infrastructure Recovery
Request (JIRR) Program
Abbreviated Consultation Process (ACP)
Semi-Annual Report: SEPTEMBER 2020**

City of New Orleans

Executive Summary

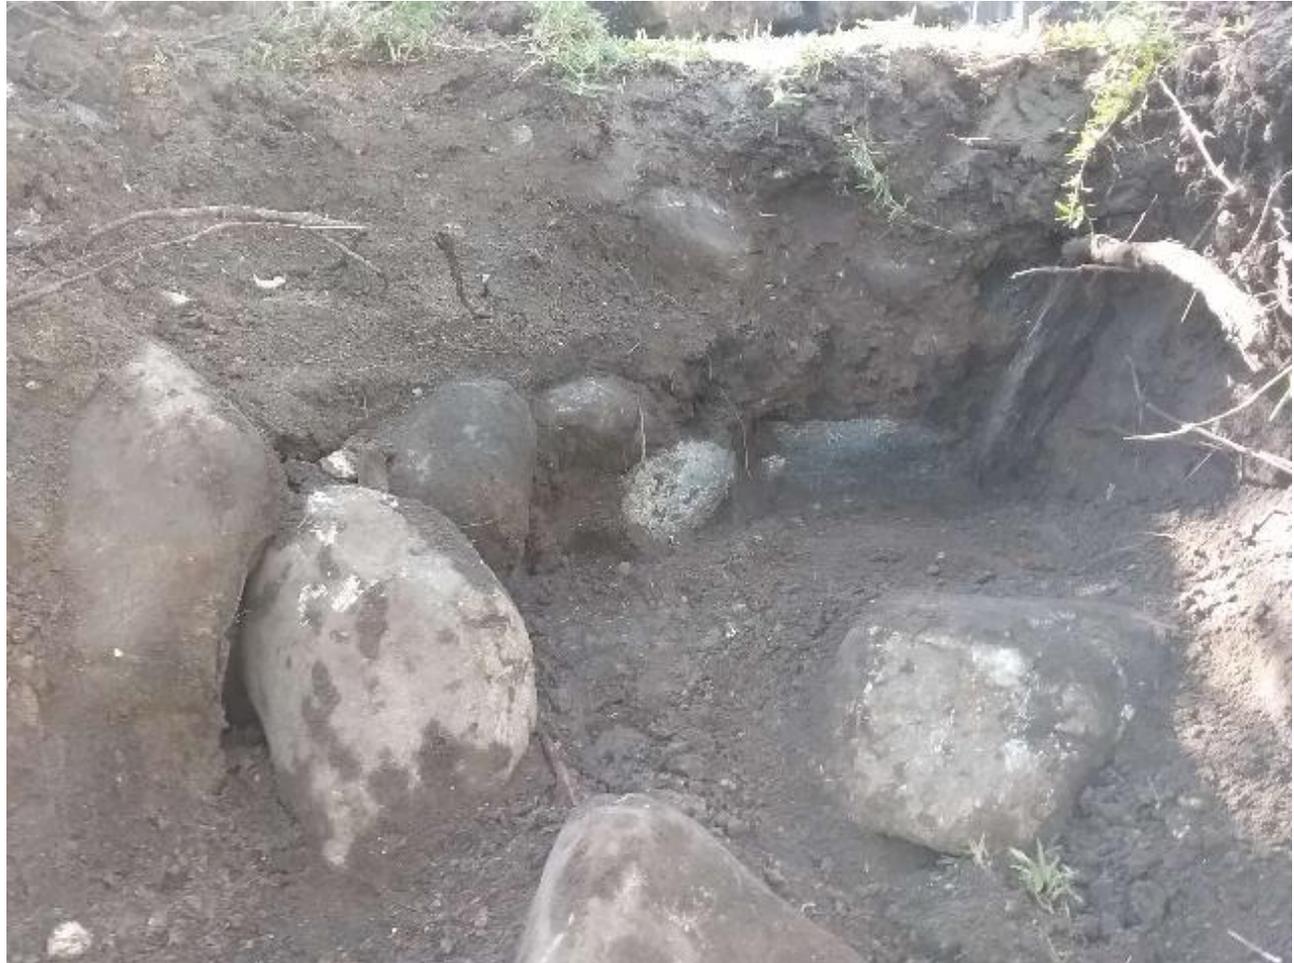
rocks - the upright (75 degree angle) curbstone assemblage suggests that they are in their original location, but disturbed by various agents including the sewer house connection activity.

Figure 4. In situ granite curb at 75 degree angle next to cobblestones observed along Bayou Road.

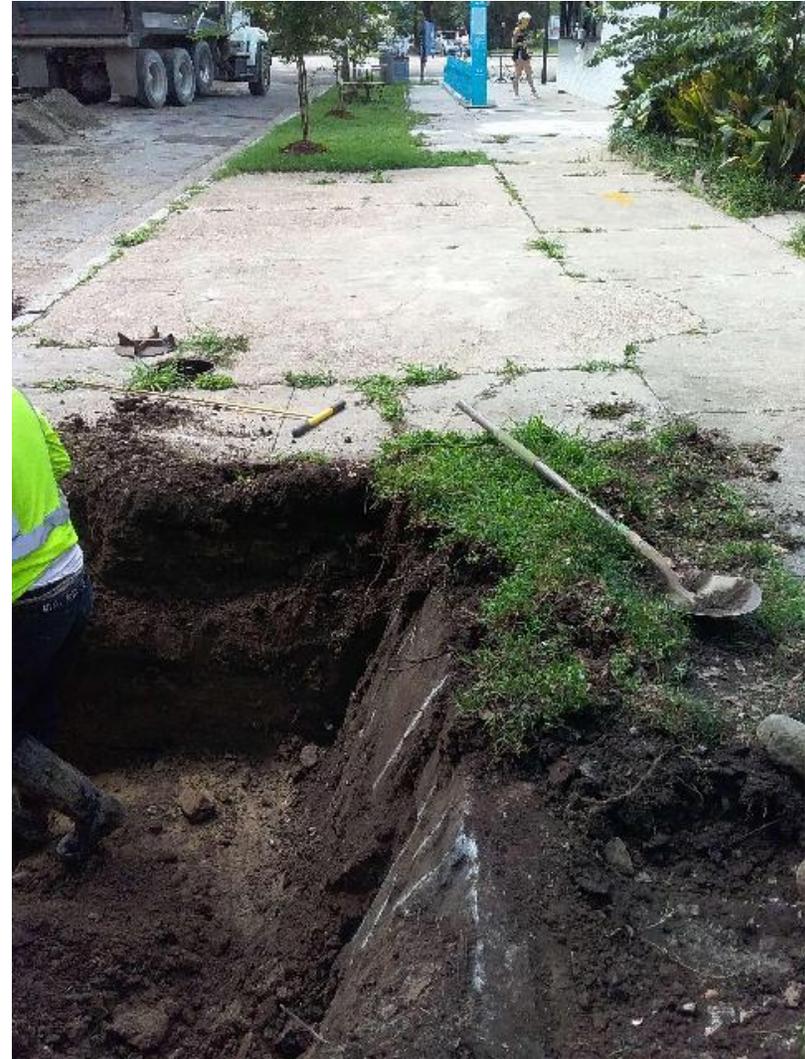
A last angled curb at the same 75-degree angle was observed in a sewer house connection in front of 2126 Bayou Road. In this location, the sewer house connection had tunneled through the angled granite slab, an indication that it was older than the connection (Figure 5). Nearly all the city had been converted from the privy waste system to the new piped sewer system by 1920, suggesting that the angled curb system of Bayou Road must be older (Colton 2000:94). Unfortunately, the building was only illustrated by Sanborn starting with the 1940 series where it is labeled as a store (Sanborn Map Company 1940: Sheet 128). If it had appeared on the 1908 Sanborn then we could infer that the angled curb system was in place by that date.

Figure 5. Granite curb with modifications to allow for house connections; curb continues to the end of the street.

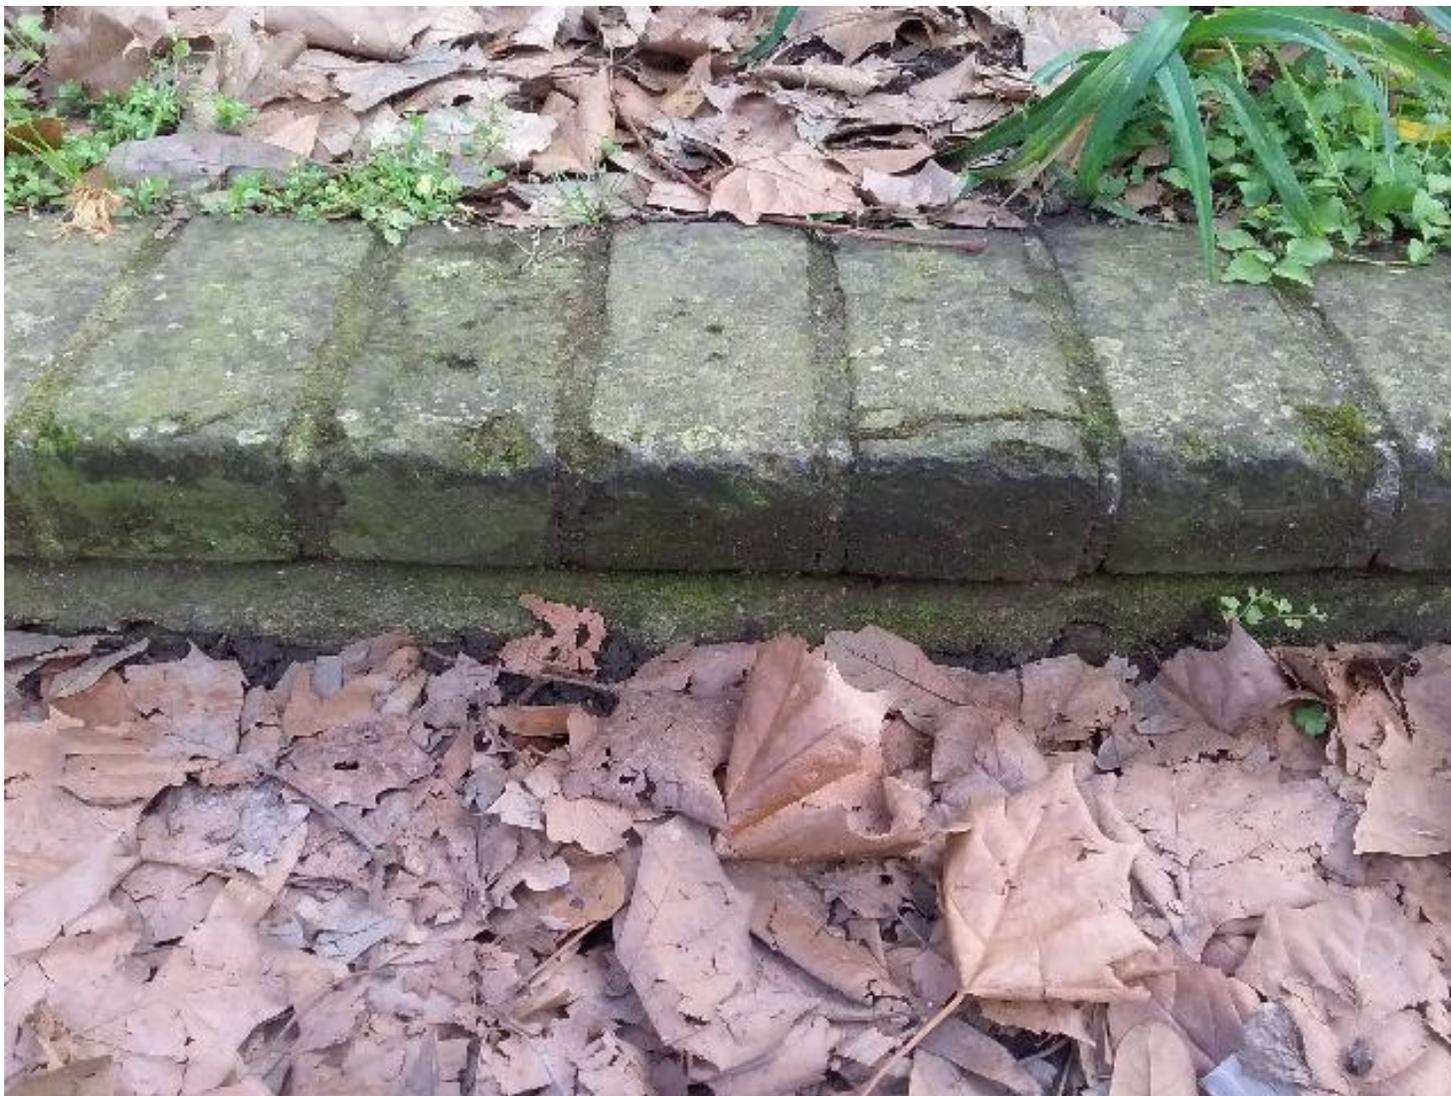
Figure C1. Contributing status yet to be determined Brick Curb, 628 Pacific Avenue Algiers Point, NRHD, Period

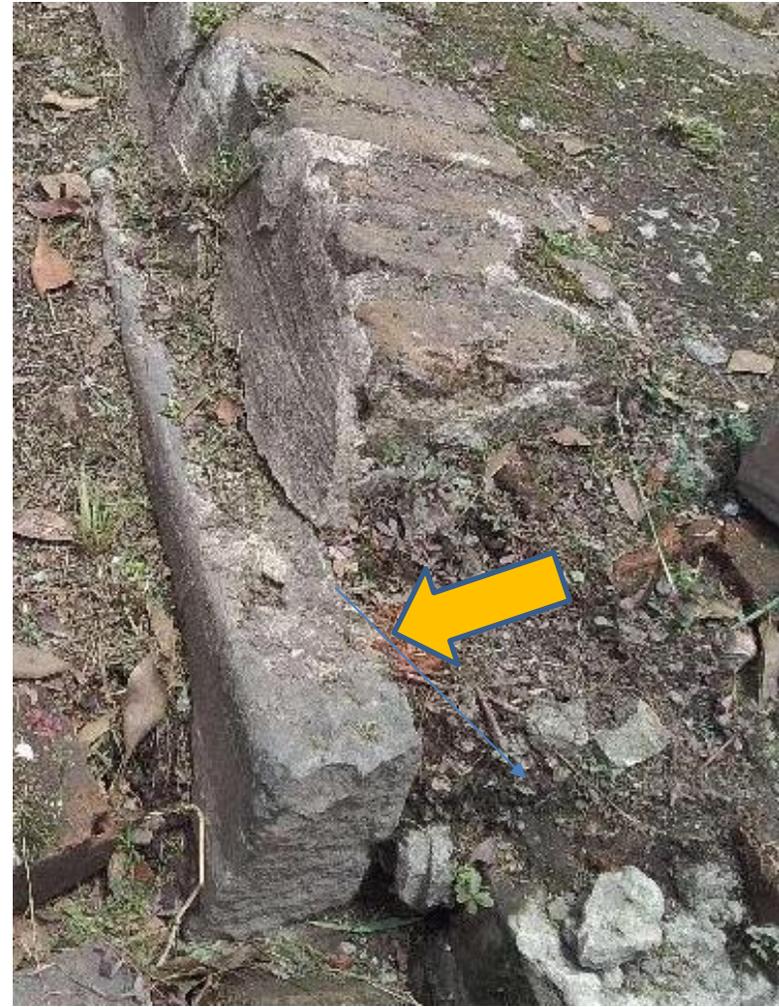
*Figure C5. Contributing status yet to be determined: Brick
Curb resting on top of bluestone curb (SEE ARROW), along
3000 block of Camp Street near catch basin, Garden District,
NRHD/NHL, Period of Significance: 1832-1959*

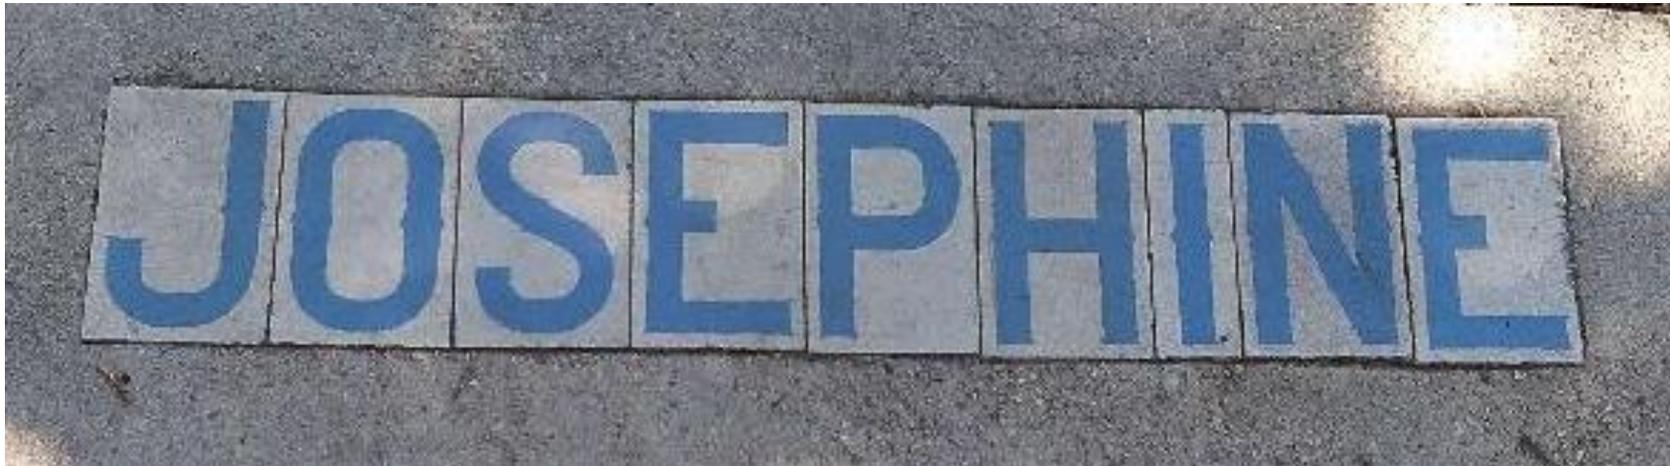
Figure C6. Contributing: Historic cement or porcelain tile, "JOSEPHINE", near 1401 Josephine Street, Garden District, NRHD/NHL, Period of Significance: 1832-1959

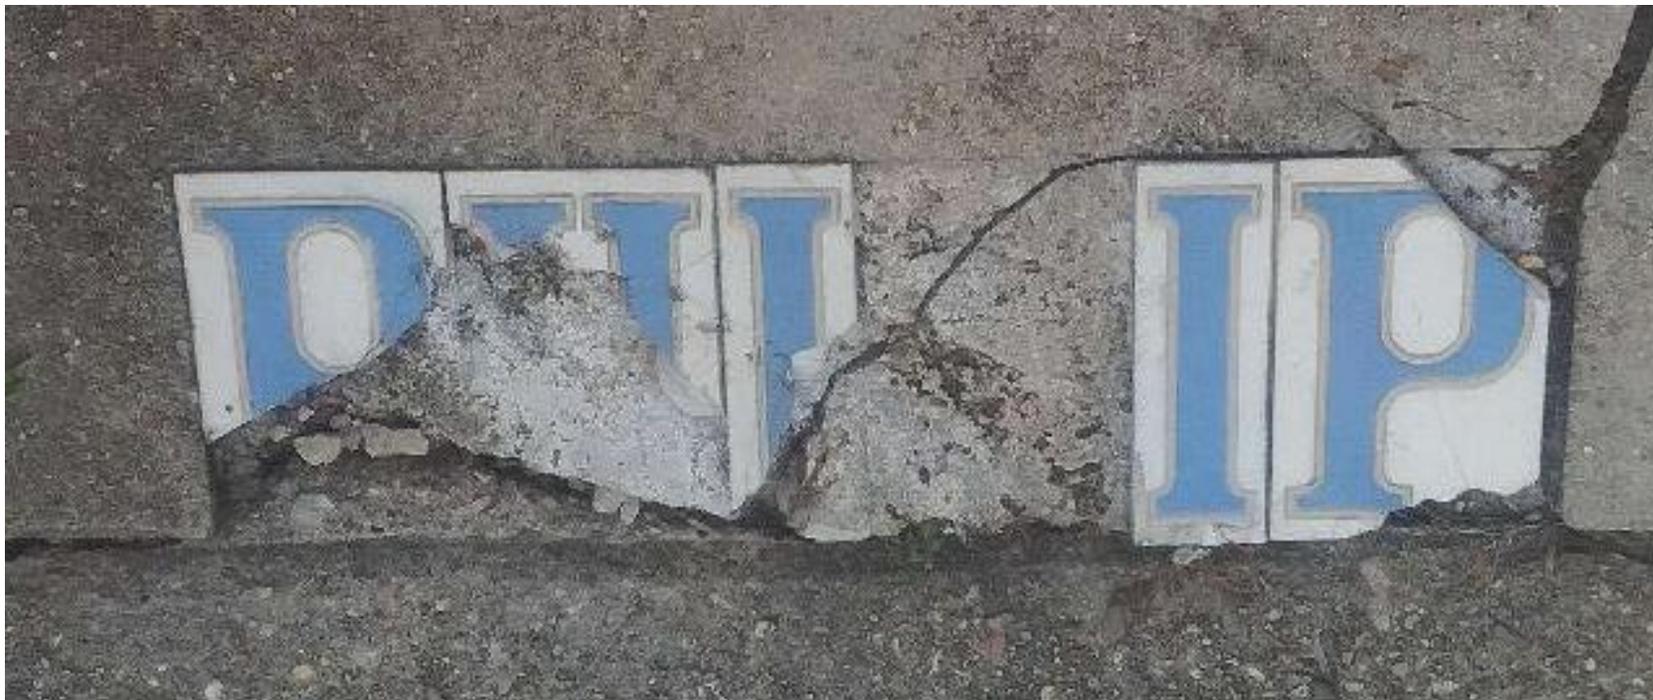
Figure C7. May no longer be contributing: Chipped street name tile with missing letter, "PHILIP", near 1332 Philip Street, Garden District, NRHD/NHL, Period of Significance: 1832-1959

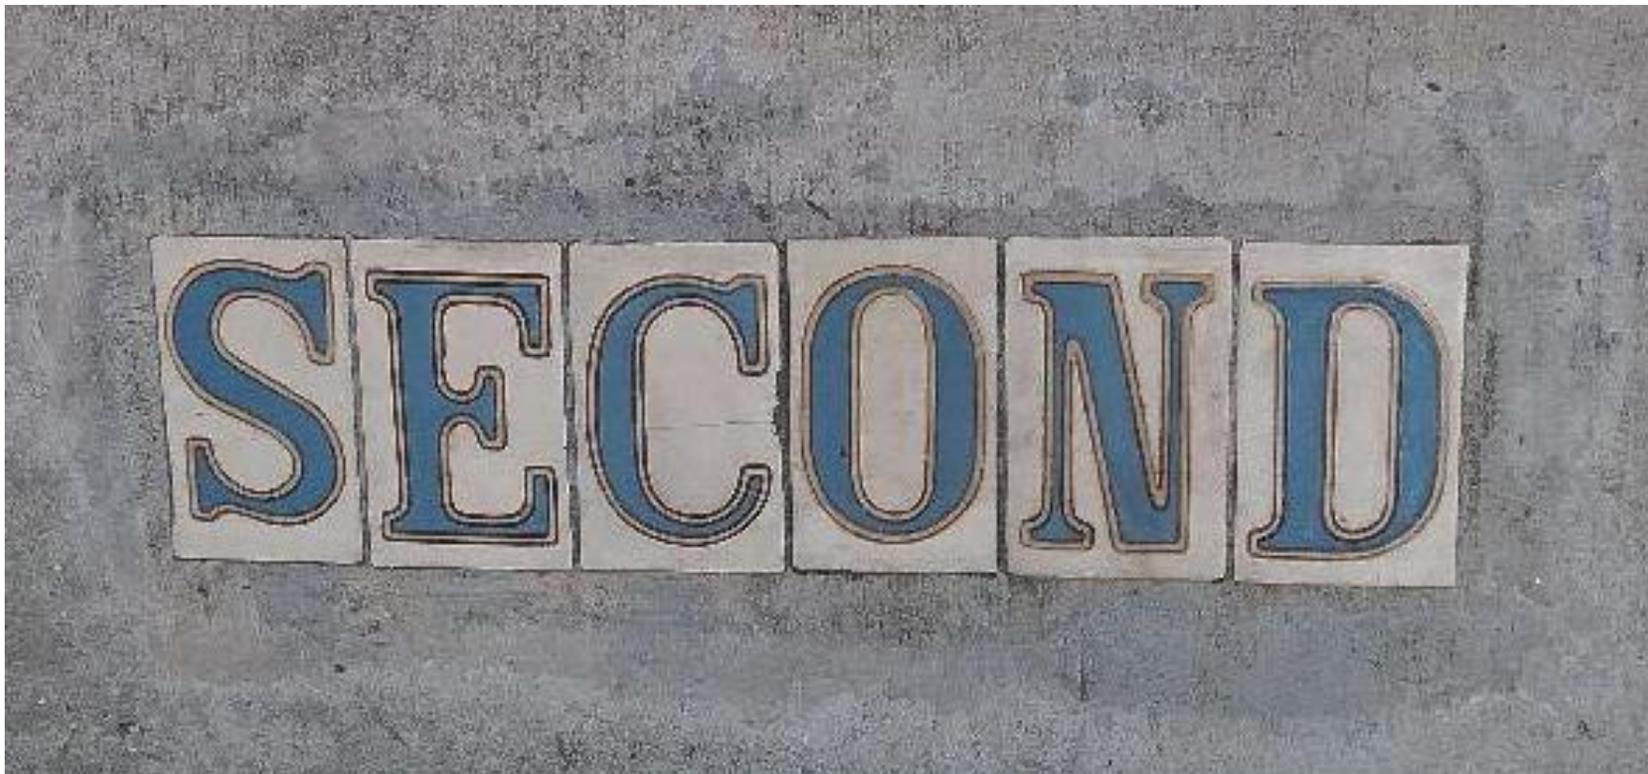
Figure C8. Non-Contributing, but compatible: Recent newer ceramic tile installed with a bright yellow outline around blue font against a white background (NOTE RECENT CONCRETE WORK), near 2426 Magazine St, Garden District, NRHD/NHL, Period of Significance: 1832-1959

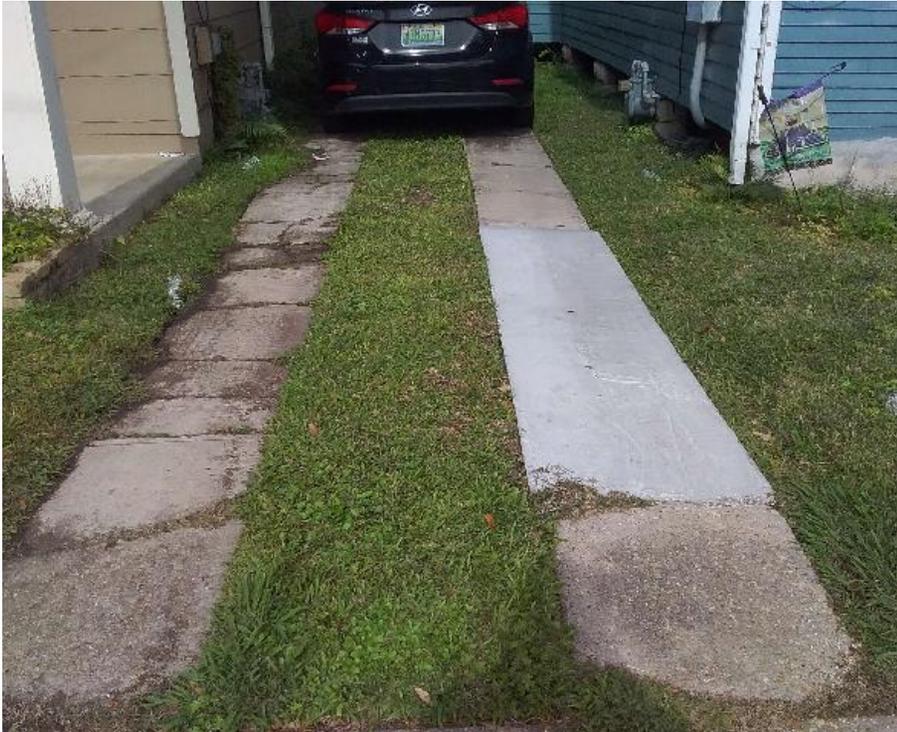
Figure C10. Contributing Two Track Driveway with concrete patch on middle of right strip, 725-27 Voisin Street, South Lakeview, NRHD, Period of Significance: 1910-1951

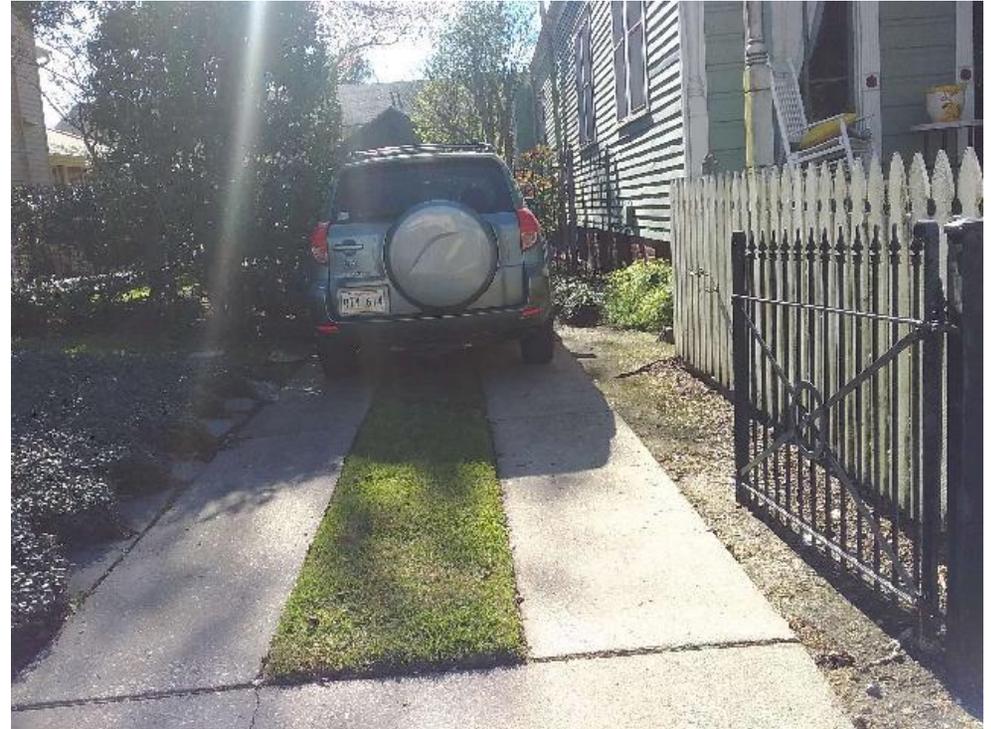
Two-track driveways were also discovered in Algiers Point NRHD (POS: 1850-1946) and were assessed for integrity (see Figures C11 and C12). In Figure C11, while the two-track driveway sharing a lot with a double gallery neo-classical revival home may not be an original feature, the timeframe for this feature fits within the later part of the POS for Algiers Point NRHD. The two-track driveway remnant, however, at 816 Newton Street, has lost many aspects of its integrity (material and workmanship) in addition to its setting due to the loss of the adjacent building. Therefore, it is no longer a contributing element to the historic district (see Figure C12).

Figure C11. Contributing Two Track Driveway, 235 Lavergne Street, Algiers Point, NRHD, Period of Significance: 1850-1946
