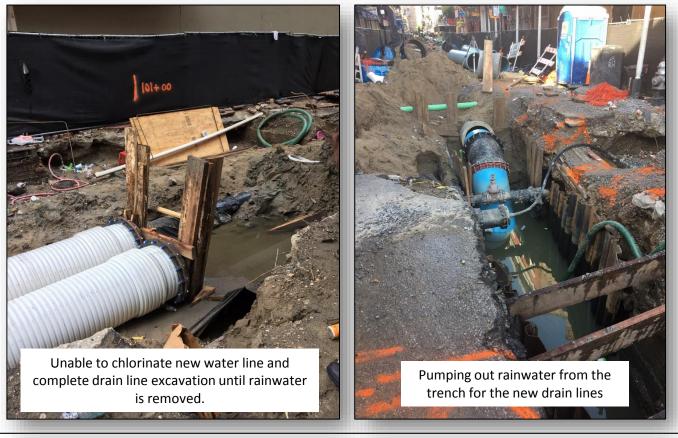
- 1. The aggressive project schedule put almost every activity on the critical path, with almost no time built into the schedule for rain delays.
 - June 2017 was third wettest month on record, with over double the average annual rainfall
 - <u>15</u> work days have been lost so far due to weather delays

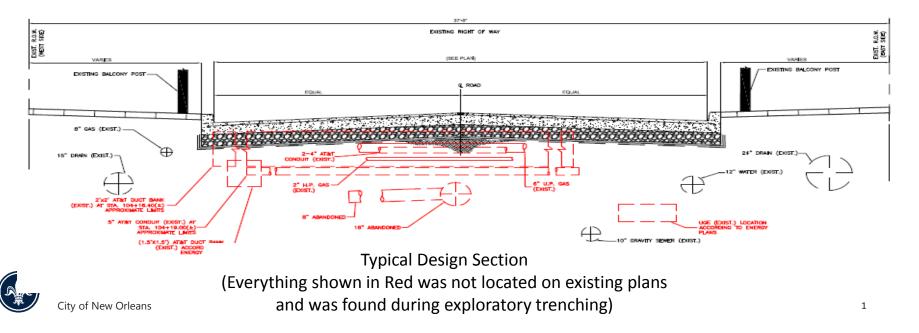
- 2. The exact locations and size of almost all of the utility lines underneath Bourbon St are either missing or inaccurately depicted on our available as built plans.
 - Exploratory trenching in multiple locations in each block is the only reliable way to verify where the utility lines are buried, how deep they are buried, and how big they are.
 - A conventional design-bid-build process would have resulted in an excessive amount of change orders and lost time during construction.
 - <u>3</u> work days have been lost due to necessary exploratory trenching to support field design and safe construction, but have had <u>no</u> major water, sewer, gas, or electrical outages due to damage during construction. Have experienced some limited AT&T service outages due to a line that was damaged during excavation work in the 100 block that have been resolved.

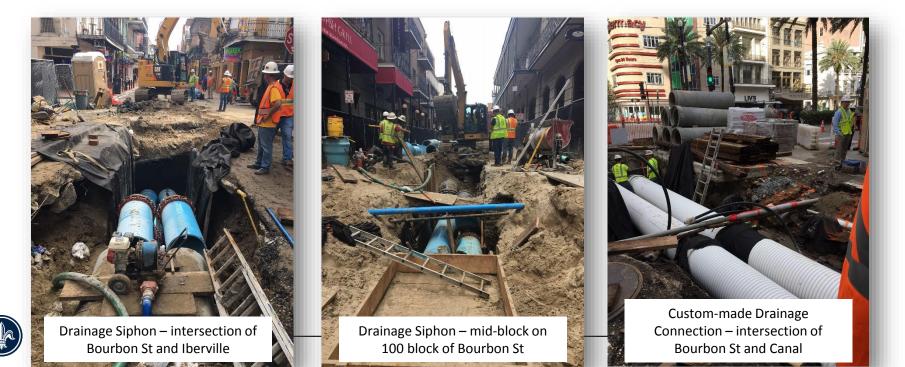
- 3. Space underneath Bourbon St is even more limited than anticipated to support the installation of new underground utility lines that are in most cases larger to meet current design standards.
 - Due to conflicts underground with multiple utility lines in a very limited space, there are no straight, standard utility line installations.
 - Special utility line installations take longer and cost significantly more (3-4 times as much) than originally anticipated.
 - <u>8</u> additional work days have been needed so far to resolve unforeseen sight conditions (i.e., utility conflicts with off-sets, siphons, custom-built manholes, and other engineering measures.)

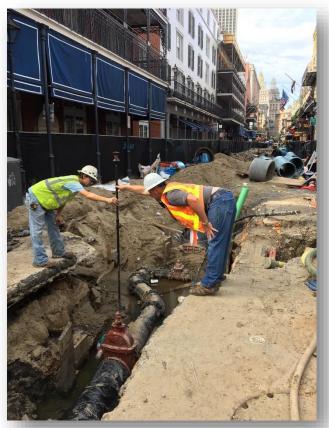
- 4. The condition of the underground utility lines/duct banks is even worse than anticipated and this is our one opportunity to get it right.
 - Discovered sewer service connections from businesses connected to the drain lines and grease globs in the drain lines. This is a violation of the sanitary code and we are dealing with fixing these and in some extreme cases have had the businesses fined to get in compliance. These service connections will be cleaned and connected to the sewer main as appropriate.

- Discovered roof drain lines from buildings terminating underneath the street, but not connected to the drainage system this is prevalent in about 20% of the businesses (in some cases allowing runoff to flow into utility manholes). This is a violation of the plumbing code. These roof drain lines will be connected to the new drain lines.

- Currently, in some cases, the nearest closure valve for the water lines is located on N Rampart St (3 blocks away). Installing additional water valves to allow work to install a new water service connection for a business or address a leak on a block to only impact service on that specific block instead of multiple blocks as is currently the case.

- 11 work days have been lost do to unforeseen site conditions
