**Joint Infrastructure Recovery
Request (JIRR) Program
Abbreviated Consultation Process (ACP)
Semi-Annual Report: SEPTEMBER 2020**

City of New Orleans

Executive Summary

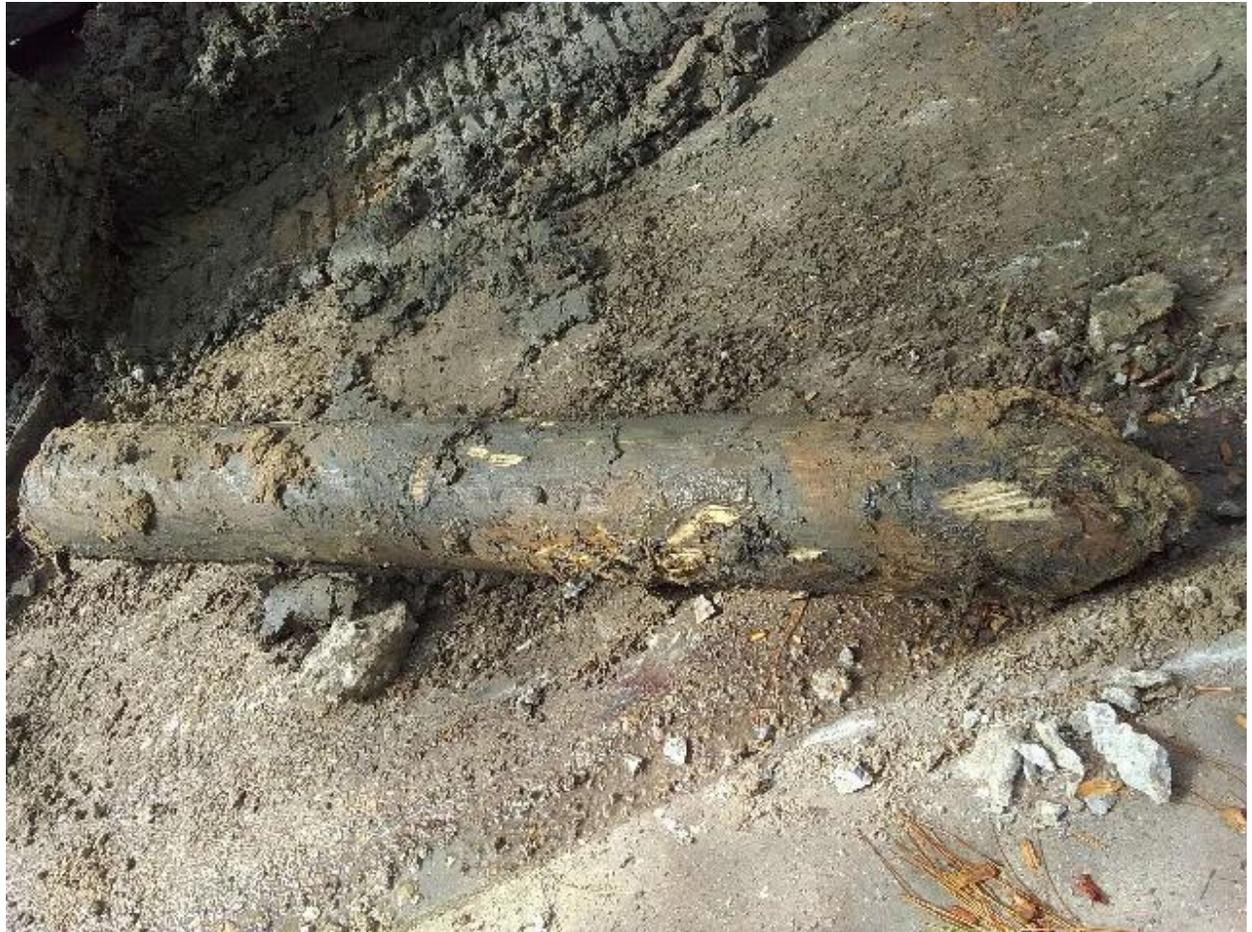
Out of place pilings were also noted on Killdeer Street. They were first observed in situ not far from the cul-de-sac in the trench around the 30 and 32 Killdeer property line and were thought to be utility trench shoring, likely related to structures once extant on the lakefront. Further to the east of 30 Killdeer, none were observed in situ. These pilings were all round but varied in size. One was 30 cm diameter and 170 cm long (Figure 23). All except one (see 2 Killdeer Post above) were noted within and to the west of the 28 Killdeer midden.

Figure 23. One 30 cm diameter and 170 cm long piling east of 30 Killdeer property.

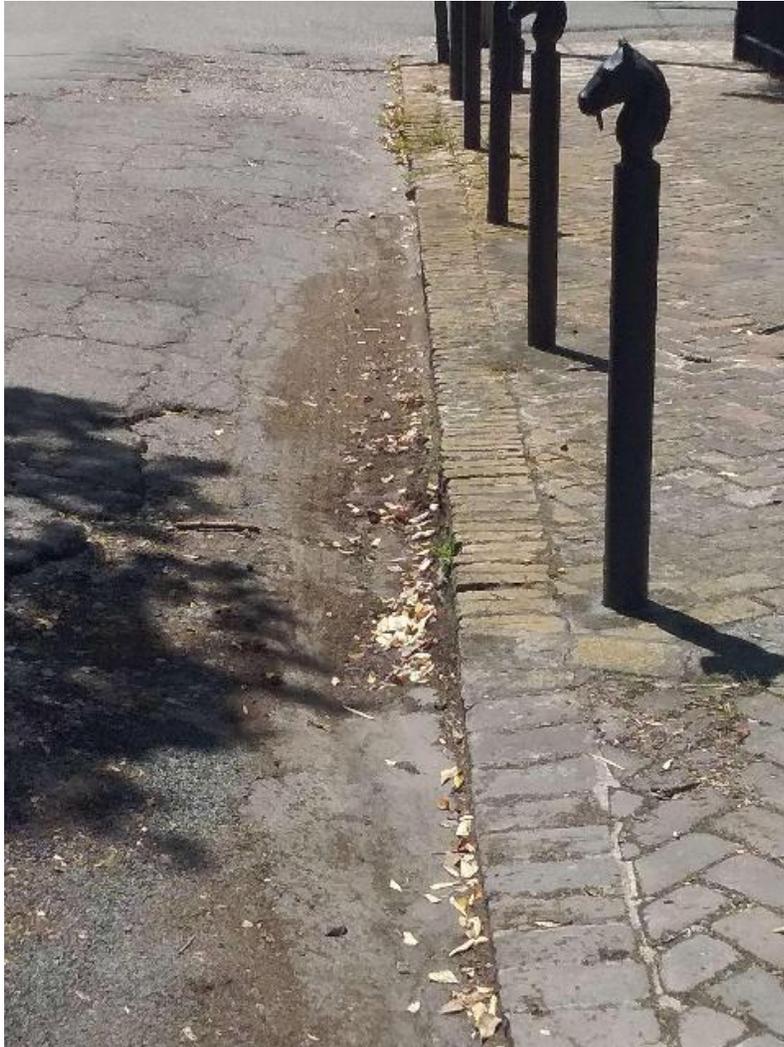
Figure C2. Contributing status yet to be determined: Brick Curb, along corner 1200 block of Ninth Street, Garden District, NRHD/NHL, Period of Significance: 1832-1959

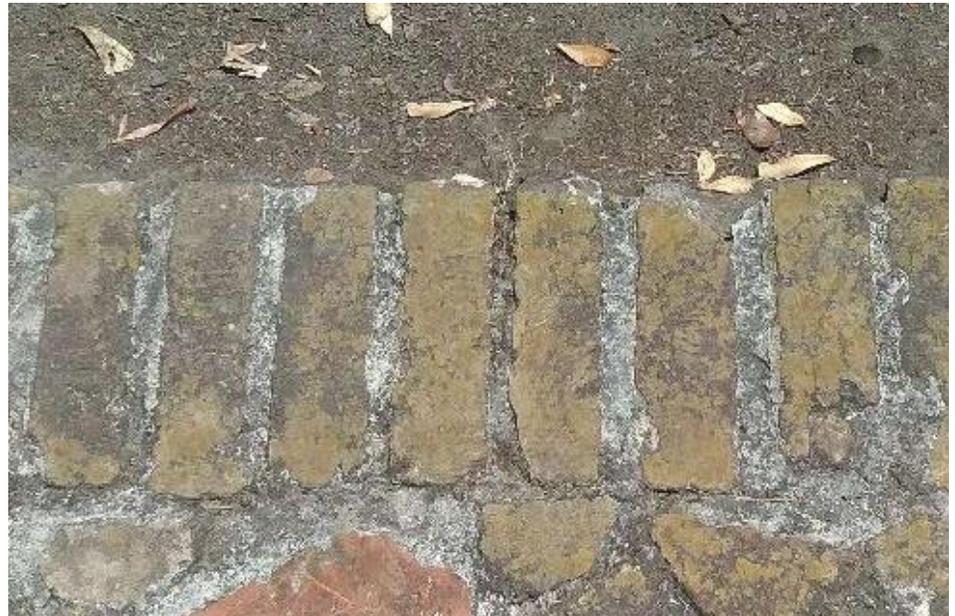
Figure C3. Contributing status yet to be determined Detail of Brick Curb, along corner 1200 block of Ninth Street, Garden District, NRHD/NHL, Period of Significance: 1832-1959

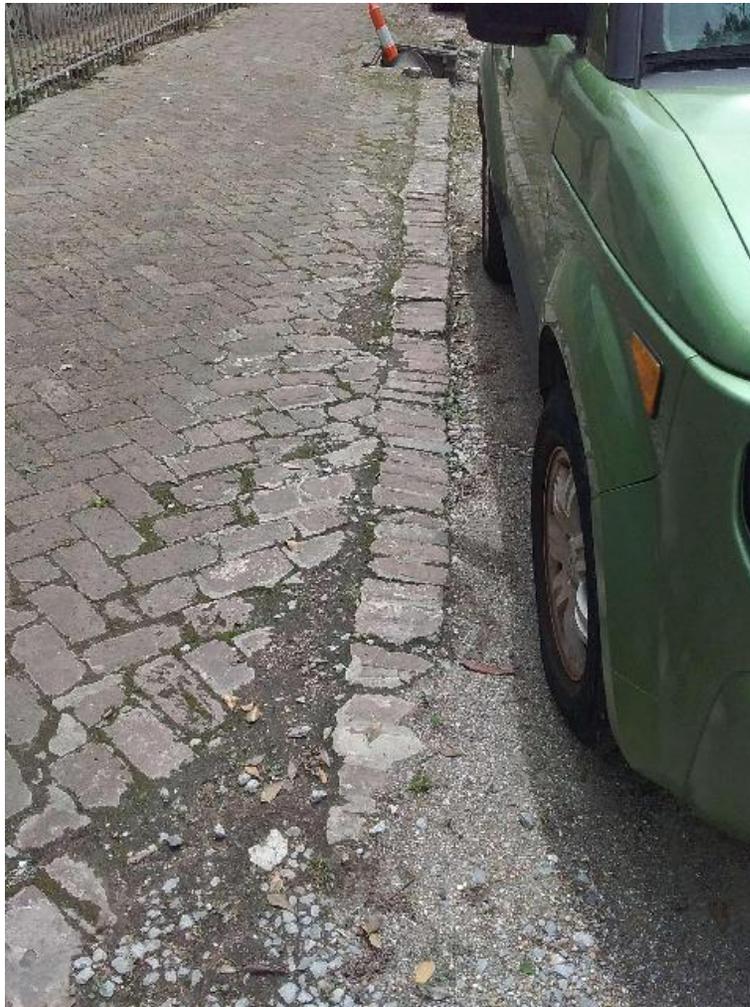
*Figure C4. Contributing status yet to be determined:
Length of Brick Curb, along 3000 block of Camp Street,
Garden District, NRHD/NHL, Period of Significance: 1832-
1959*

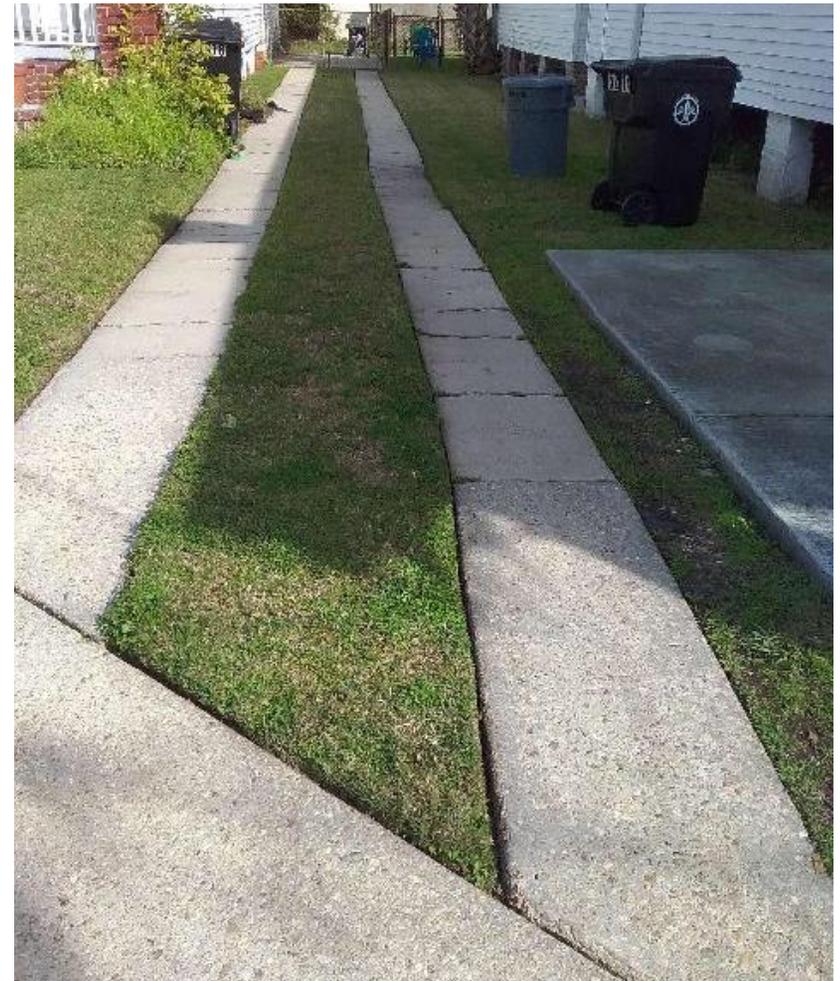
As expected, many two-track driveways were found in South Lakeview NRHD, a district which lends its major period of development to the early part of the twentieth century (POS: 1910 -1951). All were assessed for integrity and almost all were found contributing to the historic district (see Figures C9-C10). In Figure C10, the driveway strip to the right was repaired with new concrete not matching in color and perhaps texture, however, overall, the feature still meets most of the seven aspects for integrity such as location, design, setting, workmanship, feeling and association, if not material, and remains a contributing element to the district.

Figure C9. Contributing Two Track Driveway, 5216-18 Hawthorne Place, South Lakeview, NRHD, Period of Significance: 1910-1951
